Common Installation Issues

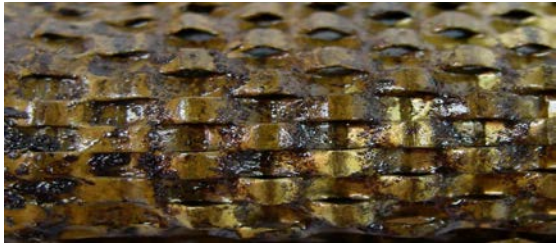
BEFORE Hot Flush

Symptom	Cause	Preventative Action
<ol style="list-style-type: none"> 1. Decreased engine performance 2. Shifting erratically 3. Sticking valves 4. Excessive heat 5. Repeat failures 	Contamination caused by not properly flushing the cooler	Flush the transmission cooler as part of the installation process

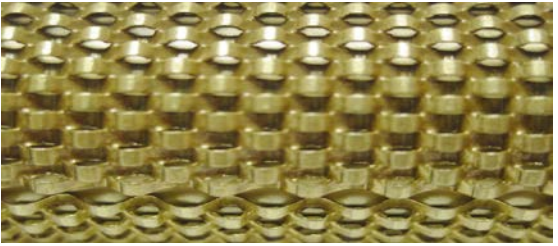
AFTER Hot Flush

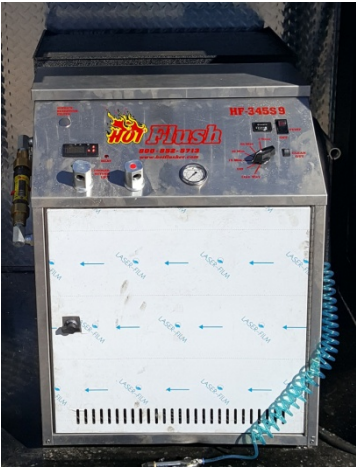
Hot Flush Machine

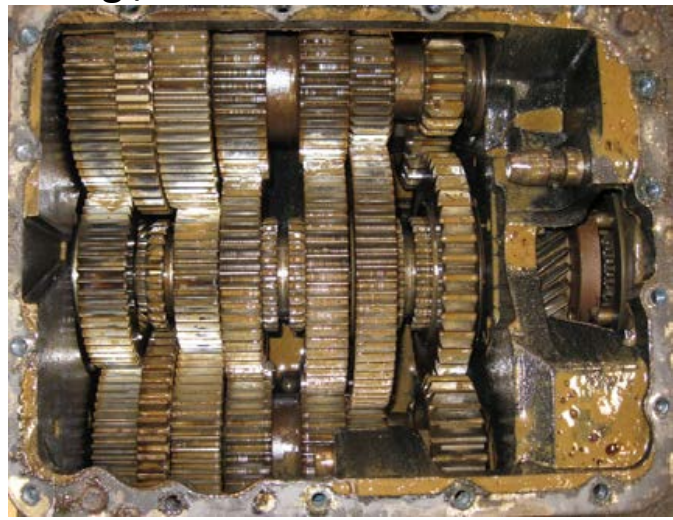
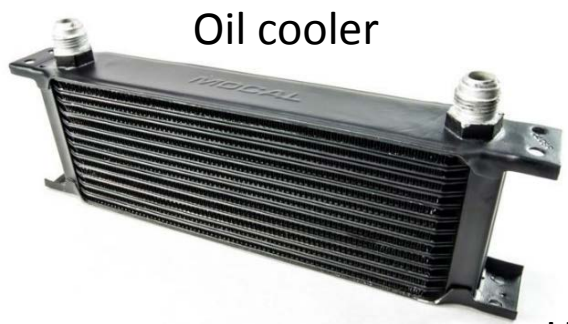
Symptom	Cause	Preventative Action
<ol style="list-style-type: none"> Excessive heat Premature bearing failure Oil breakdown Grinding in high & low Oil leaking from breather 	<ul style="list-style-type: none"> Defective cooler Contamination due to not flushing cooler Mixed lubricants Antifreeze or water in heat exchanger leaking into transmission Glyco causes synchro lining to come off 	<p>Flush system prior to installing the remanufactured unit. Utilize a new oil cooler and/or heat exchanger.</p>

Failed oil cooler causes brownish coloring / indicates oil contamination

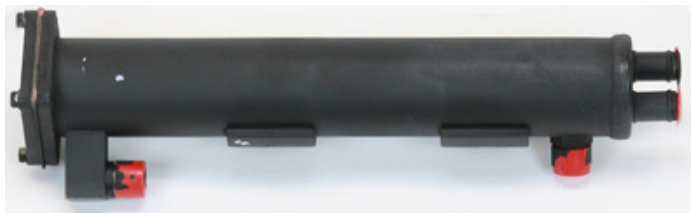
Oil cooler

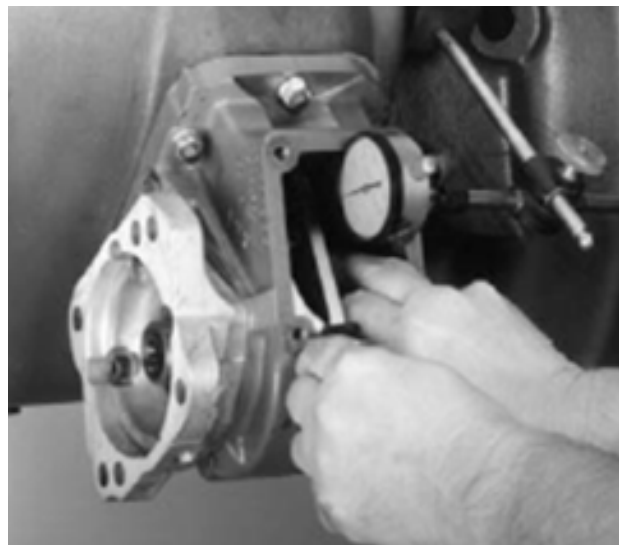
Backlash check using dial indicator

Symptom	Cause	Preventative Action
<ol style="list-style-type: none"> Hard shifting Noise Premature transmission failure 	<ul style="list-style-type: none"> Improper cleaning of used PTO Failure to use a new PTO reseal kit Failure to set backlash properly (.006-.012) 	<ul style="list-style-type: none"> Clean PTO inside and outside. Inspect for wear, replace seal. Mount using PTO gasket shims & cooper washers on bolts.

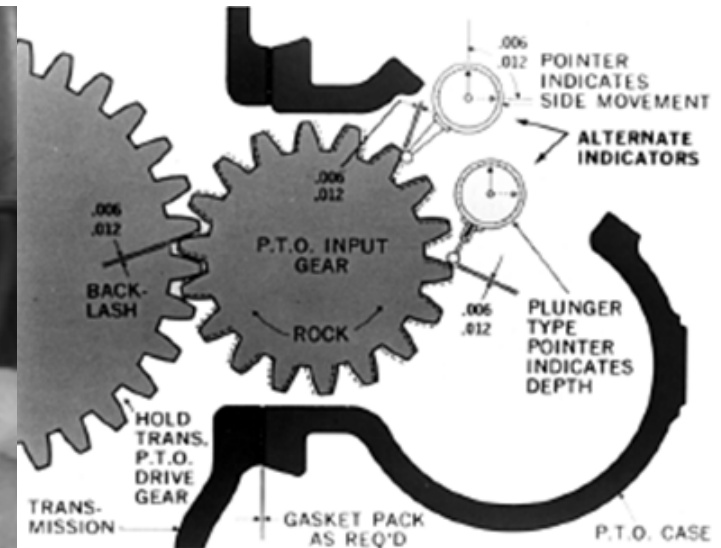
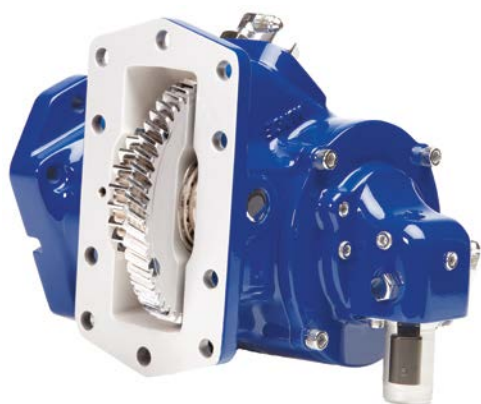
Cut-away view of backlash check

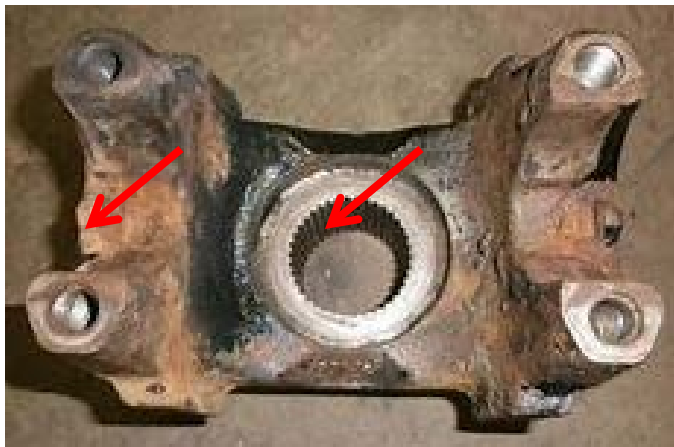
Worn End Yoke
Worn splines & U-Joint Cap

Symptom	Cause	Preventative Action
<ol style="list-style-type: none"> 1. Output shaft endplay 2. Failed output bearing 3. Vibration & leaking 	<p>End yoke not torqued to correct specification</p> <p>Not using correct torque tool</p>	<p>Upon install, check for proper torque & worn splines</p> <p>Install a new yoke if necessary</p> <p>Torque to OE specification using proper tool</p>

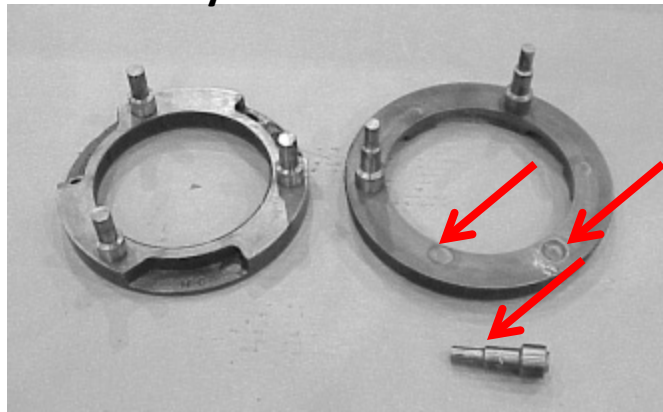
Broken synchro due to vibration

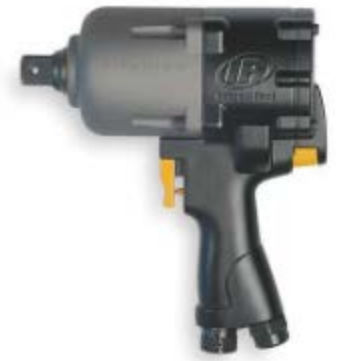
1" Air Impact
Up to 1000 ft. lb.

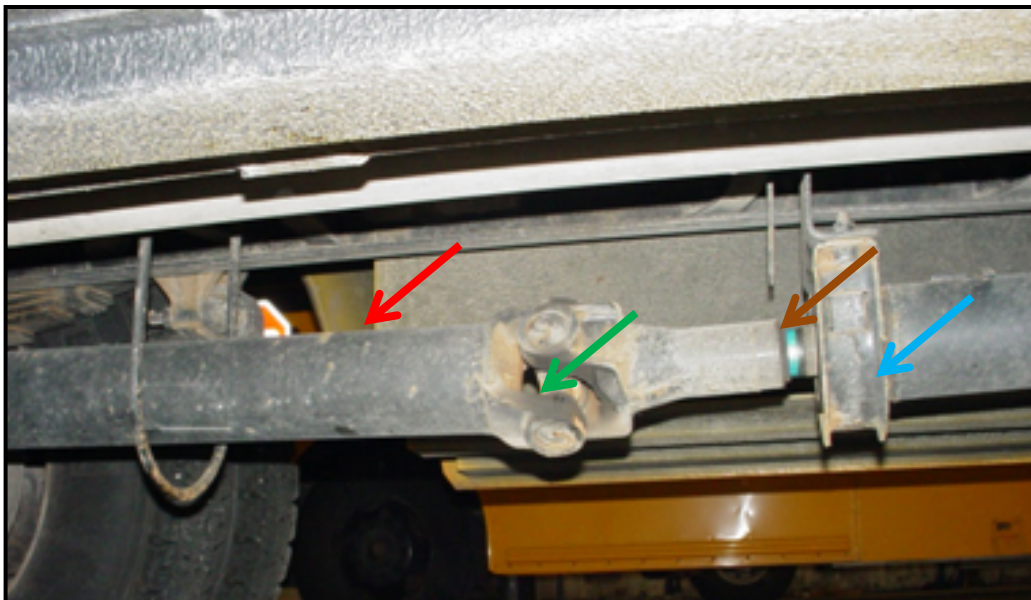
Improper driveline angle
-

Worn u-joint
-

Worn slip yoke
-

Worn carrier bearing

Symptom	Cause	Preventative Action
<ol style="list-style-type: none"> 1. Vibration 2. Noise 3. Grinding 4. Component failure 	Failure to inspect driveline and suspension components for systems deficiencies	Perform inspection prior to putting the vehicle in service Practice standard maintenance intervals

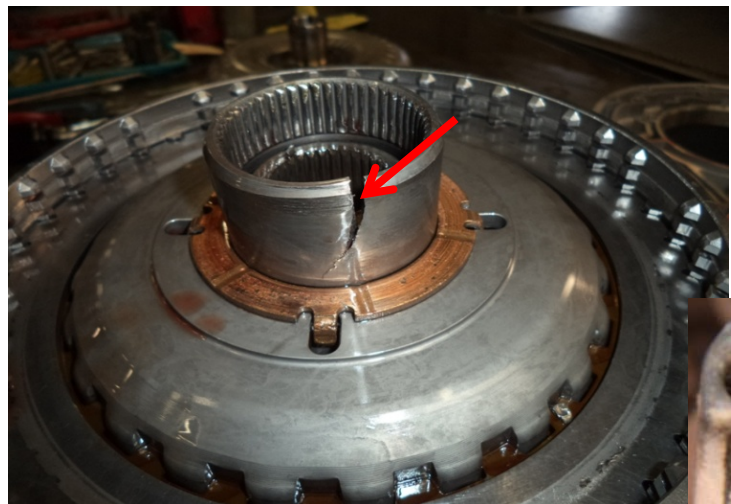
Component failures due to vibration - vibration caused by faulty driveline/suspension

Crack in clutch support hub

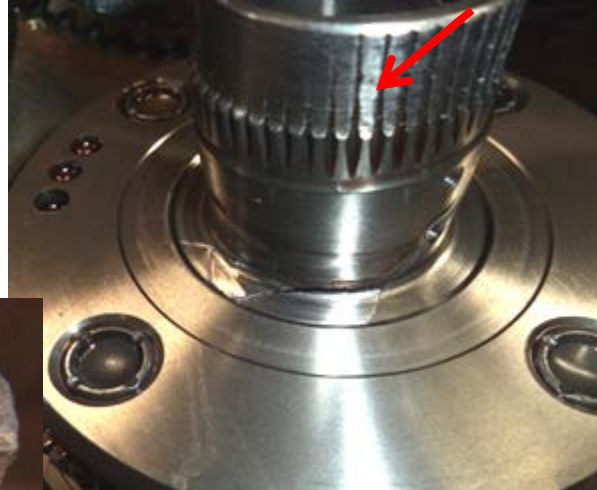
Worn splines

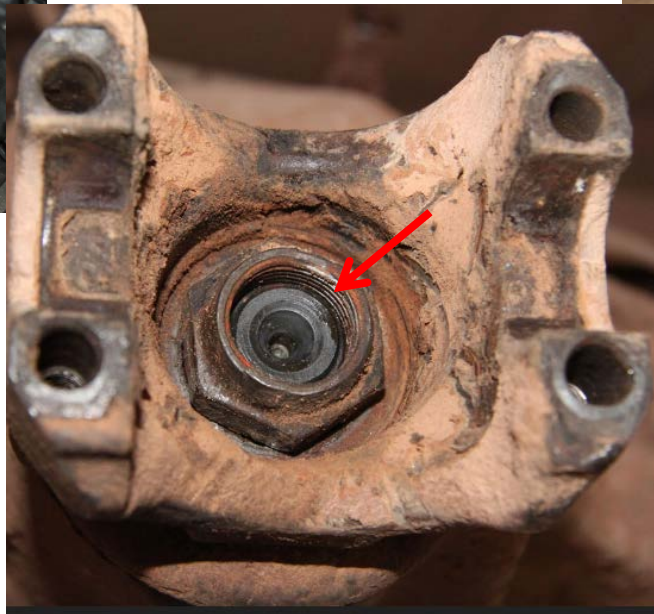
Loose fasteners
